Quantifying the Effectiveness of Installing Saturated Buffers on Conservation Reserve Program to Reduce Nutrient Loading from Tile Drainage Waters

—— April 2017 ——

“Quantifying the Effectiveness of Installing Saturated Buffers on Conservation Reserve Program to Reduce Nutrient Loading from Tile Drainage Waters”

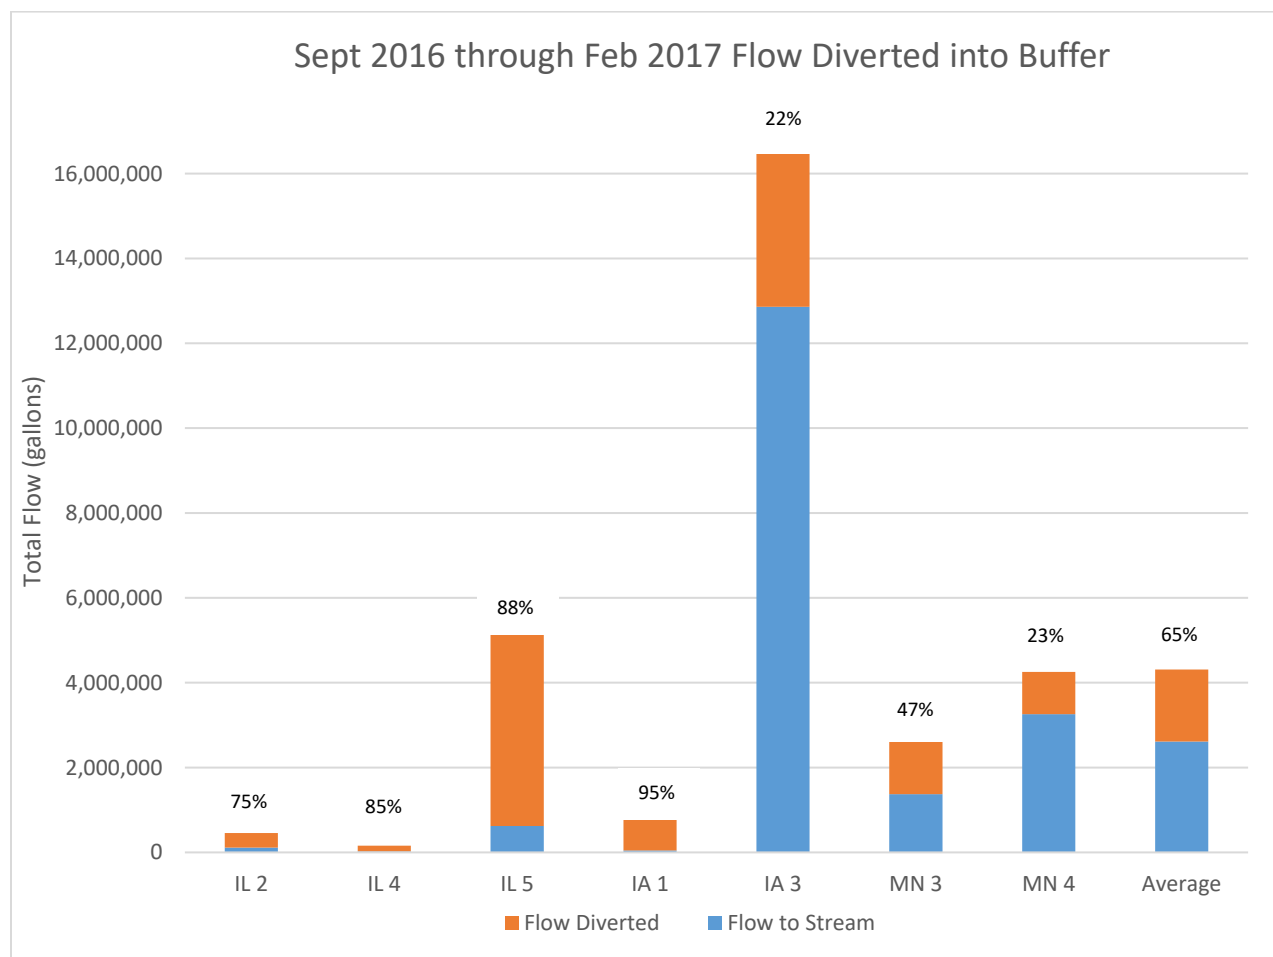
Figure 2: Flow Reduction Summary

There was flow diverted from the main tile system to the buffer in 7 out of the 9 sites (Fig. 2). The sites ranged from a low of 22% to a high of 95% with an average of 65% of the flow diverted.

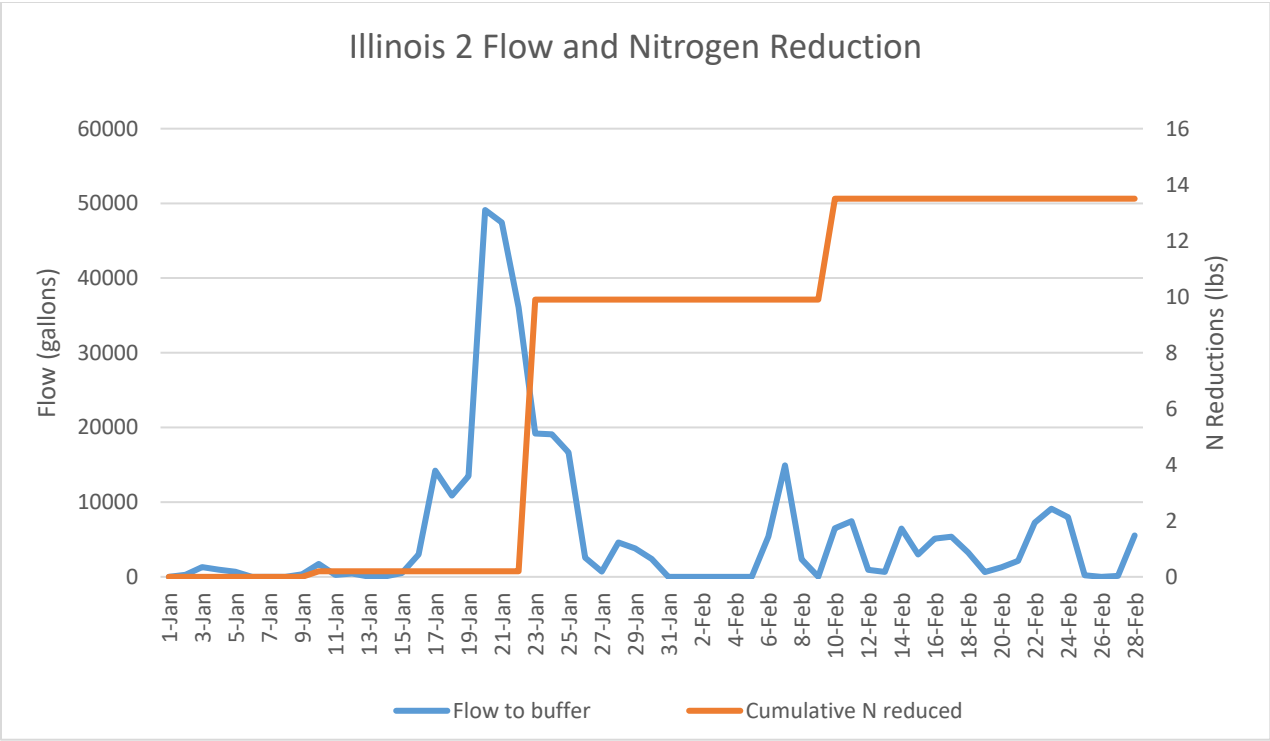
Figure 17: IL-2 Reduction

Nitrate load that went out to the buffer was determined by multiplying the flow to the buffer over a given time period by the nitrate concentration in the tile outlet for the same period. At sites where flow was measured for times when nitrate concentration was not measured, the nitrate concentration for the time closest to the flow measurement period was used. Thus, we can compute the total load of nitrate being delivered by the tile outlet for each year. To compute the nitrate reduction within the buffer, we took the average nitrate concentration in the tile outlet minus the average nitrate concentration within the wells closest to the stream. While simple, this method could be in error. For example, there two sites where the nitrate concentrations in the wells closest to the stream were higher than nitrate concentrations in the middle of the buffer. As noted in the nitrate concentration section above, the higher concentrations in streamside wells may have reflected stream bank storage where the high nitrate concentration stream water infiltrated the soil next to the stream raising the concentration in the streamside wells. In this case, our calculation of nitrate removal within the buffer may have been conservative. Throughout the 6-month study period, IA-1 removed 17.7 lbs, IA-3 removed 342.3 lbs, MN-4 removed 148 lbs of N, MN-3 removed 82.1 lbs, IL-2 removed 13.5 lbs, IL-4 removed 11.4 lbs, and IL-5 removed 60.0 lbs of nitrate-N.

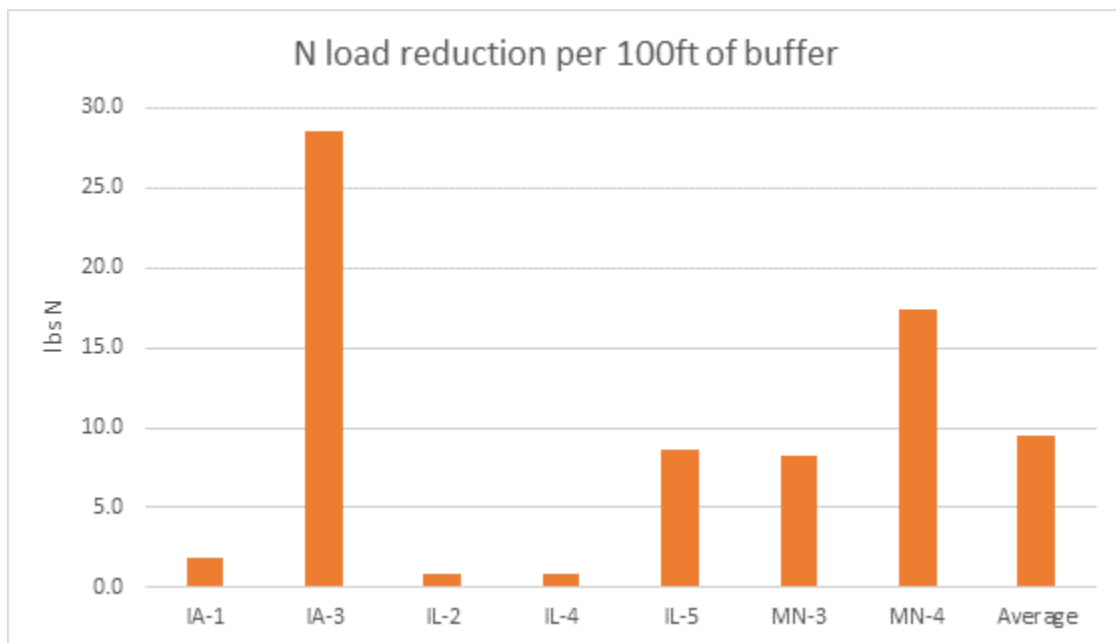
Figure 24: Reduction per 100 ft. of buffer

Considerations in future design criteria of SB should also include available length of buffer and predict the amount of gallons diverted and the pounds of nitrate removed. Fig. 24 & 25 below show the results determined in this study of the amount of flow and nitrate reduction diverted per 100 feet of buffer. The average reduction of N load per 100 lineal feet of saturated buffer is 9.5 lbs. per 100 feet for the study period. Assuming this would be at least twice as much over a 12-month period, and the fact that the study occurred during the lower flow months or the year, one could project 19 lbs. of N reduction per 100 feet of saturated buffer per year.

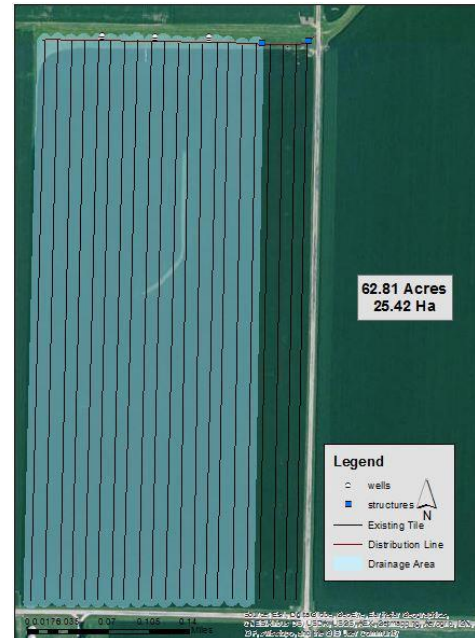
IL – 2

The saturated buffer was installed on an existing 12" tile outlet. The drained area treated by the buffer is 63 ac. or 25.4 ha. The field and buffer are at similar elevations and both are fairly flat. The field was in a corn-soybean rotation for the duration of the project.

This site is different than the others in that the existing perforated main was used for the distribution line. While this simplified the installation process it did make flow monitoring more difficult.

A series of three groundwater monitoring well transects were installed at this site. Each transect contained three wells (one near the ditch bank and the other two equally spaced between the ditch and the distribution line) for sampling the groundwater in the buffer as it moved from the distribution line to the ditch. The depth of each monitoring well is given in the table on the following page. The Well ID's correspond to the locations indicated the map above.

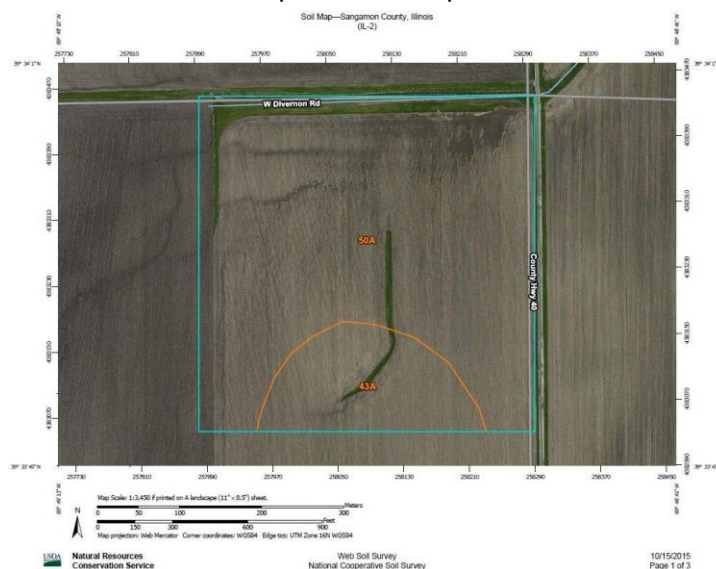
The soil map and soil series are below. Soils in the buffer are mapped as Virden silty clay loam. Soil cores showed the soil to be a silty clay loam down to 42 inches. Below this depth, the soil showed evidence of saturation starting at 30 inches on the east side of the buffer grading to 67 inches on the west side. High chroma redoximorphic concentrations above these depths indicate periodic saturation.

Map Symbol	Unit Name
43A	Ipava Silt Loam, 0-2% slopes
50A	Virden Silty Clay Loam, 0-2% slopes

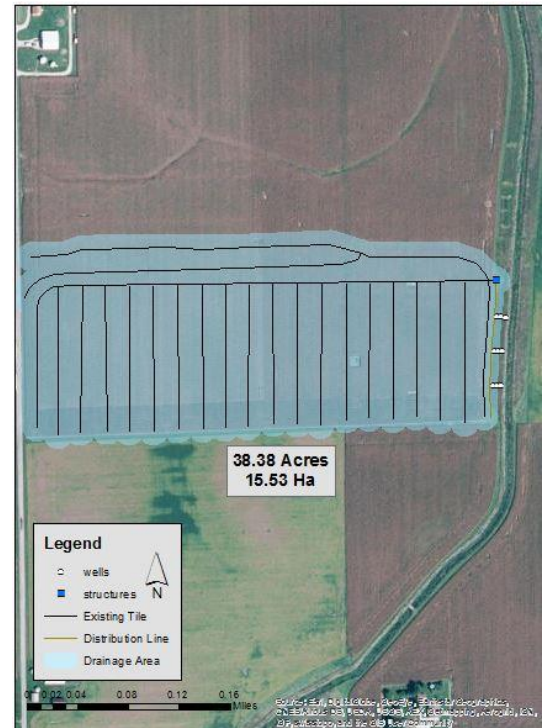
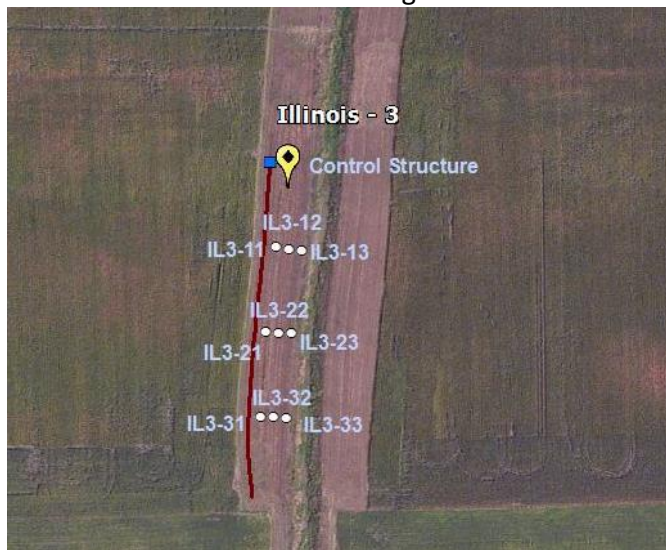
IL - 3

The saturated buffer was installed by a local contractor who used a backhoe and plow to do the work in less than one day. The work included replacing a section of the main with non-perforated pipe and installation of the control structure and distribution line. The distribution line is ~585 ft long and extends southward from the control structure.

Flow monitoring was via V-Notch weirs installed as the top stop logs in the control structure. Flow depth was measured using water level sensors. Water samples were collected approximately twice a month when the tile was flowing.

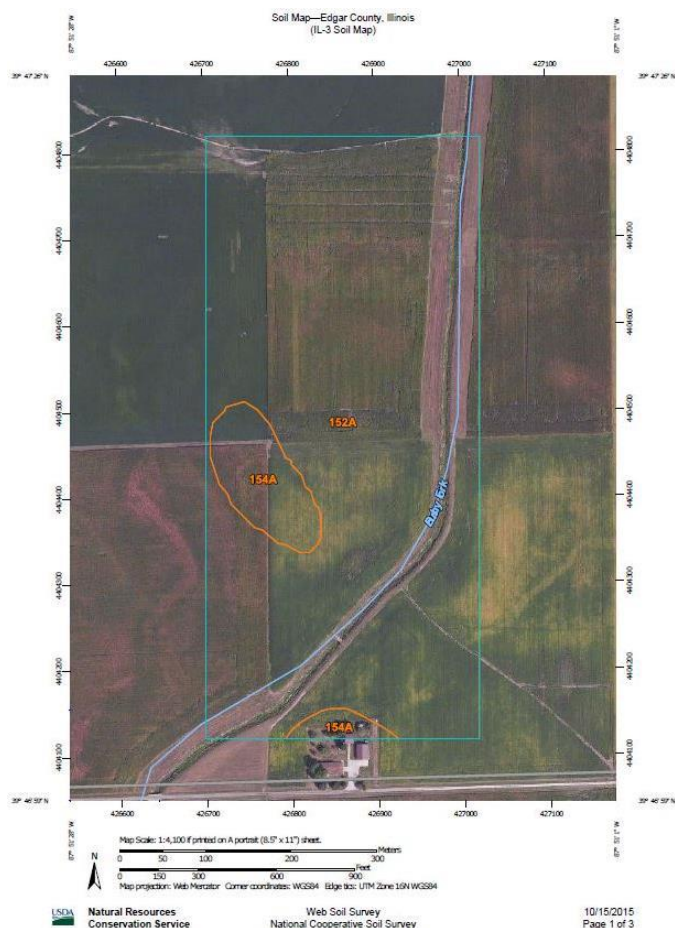
Soil organic matter was greater than about 2% in the top 48 inches. Soil pH was alkaline throughout the top 3½ feet reflecting the presence of calcareous soils below 75 inches. Denitrification is maximum at a pH between 7 and 8.5 and decreases sharply for pH ≤ 5.

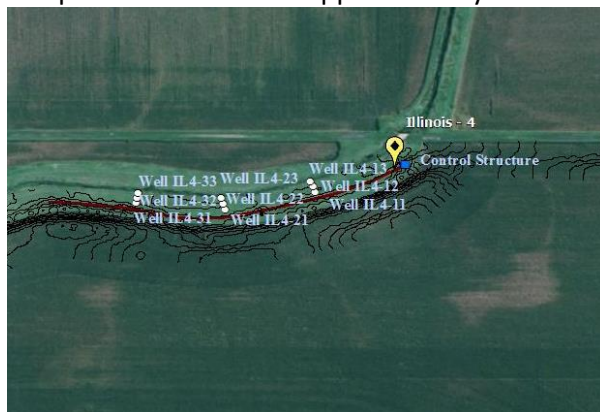
IL – 4

The saturated buffer was installed by a local contractor who used a backhoe and plow to do the work in less than one day. The work included replacing a section of the main with non-perforated pipe and installation of the control structure and distribution line. The distribution line is ~1,300 ft. long and runs roughly westward from the control structure. Flow monitoring was via V-Notch weirs installed as the top stop logs in the control structure. Flow depth was measured using water level sensors. Water samples were collected approximately twice a month when the tile was flowing.

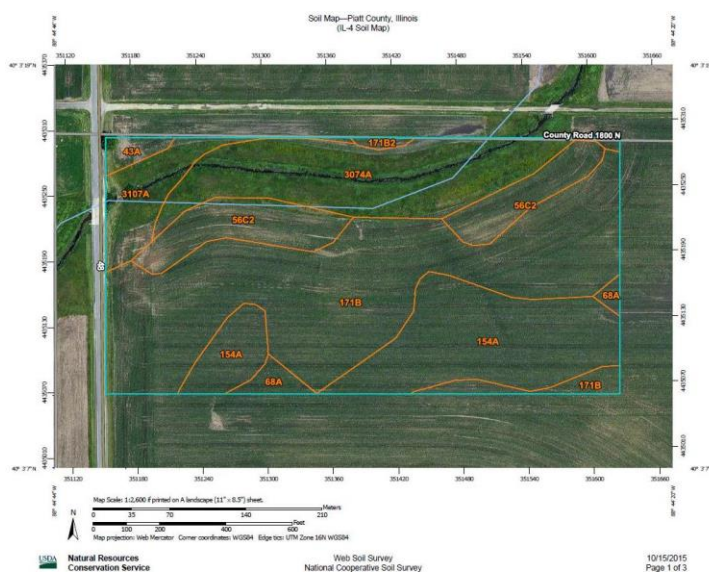
Soil organic matter was greater than about 2% in the top 48 inches. Soil pH was neutral trending alkaline with depth. Denitrification is maximum at a pH between 7 and 8.5 and decreases sharply for pH ≤ 5.

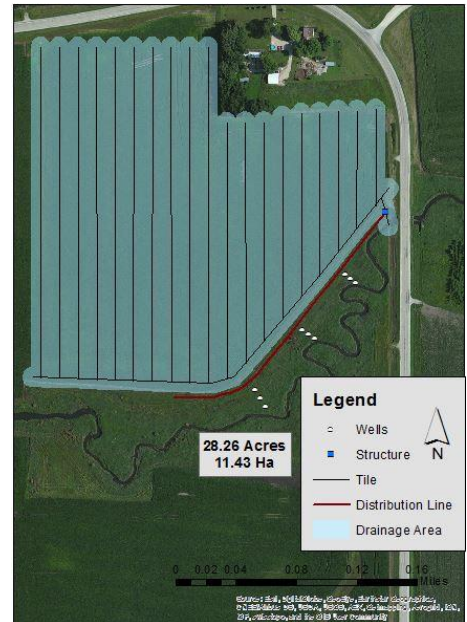
MN – 3

A series of three groundwater monitoring well transects were installed at this site. Each transect contained three wells (one near the stream bank and the other two equally spaced between the stream and the distribution line) for sampling the groundwater

in the buffer as it moved from the distribution line to the stream. The depth of each monitoring well is given in the table on the following page. The Well ID's correspond to the locations indicated on the map above.

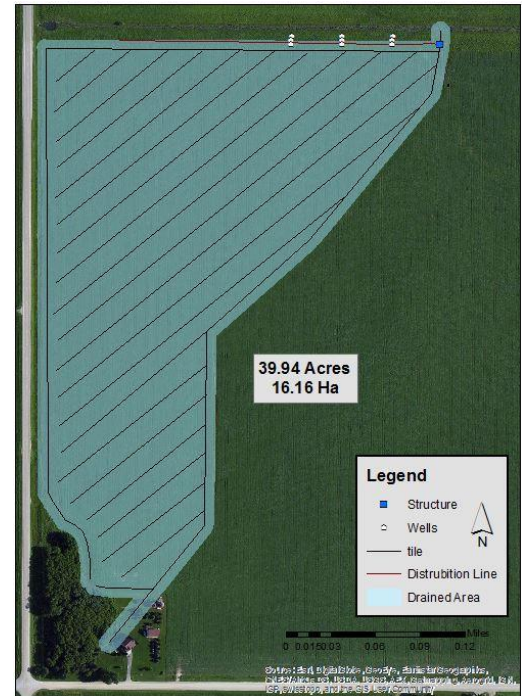
MN – 4

The saturated buffer was installed by a local contractor who used a backhoe and tile plow to do the work in less than one day. The work included replacing a section of the main with non-perforated pipe and installation of the control structure and distribution line. The distribution line is ~850 ft and runs due west from the control structure. Flow

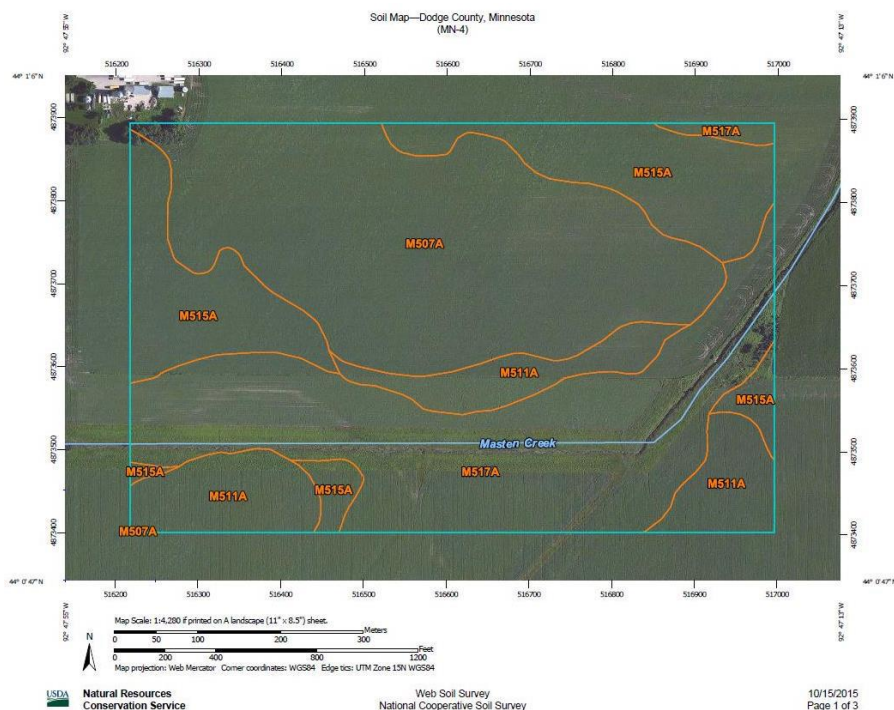
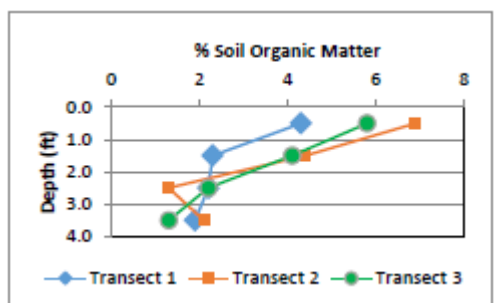
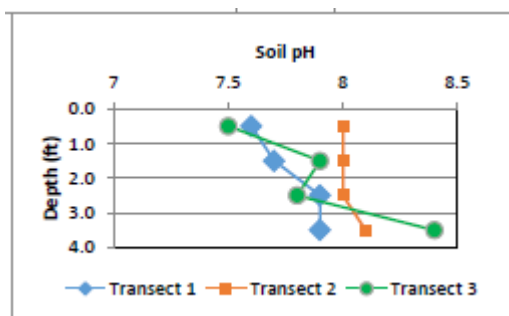
The soil map and soil series are below. Soils in the buffer are mapped as Clyde silty clay loam. Soil cores showed the soil to be loam or clay loam transitioning to sandy loam at 3½ feet. A narrow layer from about 26 to 41 was gleyed with high chroma redoximorphic concentrations indicating reducing (saturated) conditions. Under this layer was a sandy calcareous layer containing pebbles.

Soil organic matter was very high at the surface and exceeded 1.3% in the top 42 inches. Soil pH was neutral at the surface trending alkaline at depth reflecting the presence of calcareous soil at 35 – 45
